TEST REPORT

Our Ref: MM-57464/LBY

Testing of safety lock (Winlock) submitted by Securi Pte Ltd

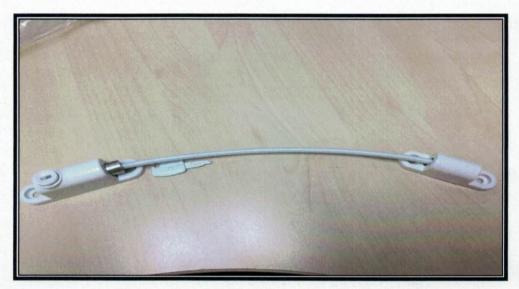
Photograph 1 show sample received for testing

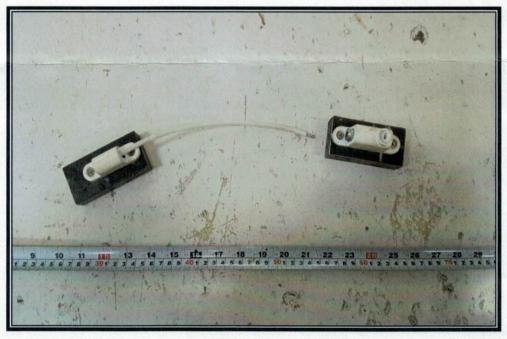
Photograph 2 shows the failure location of the testes sample

Sample Reference	Safety Lock (Winlock)
Maximum Load (kgf)	81.6
Position of Fracture	Refer to photograph 2 attached
